ON THE ISSUE OF REPAIR TECHNIQUE OF ASPHALT PAVEMENTS WITH THROUGH-THE-THICKNESS TEMPERATURE CRACKS

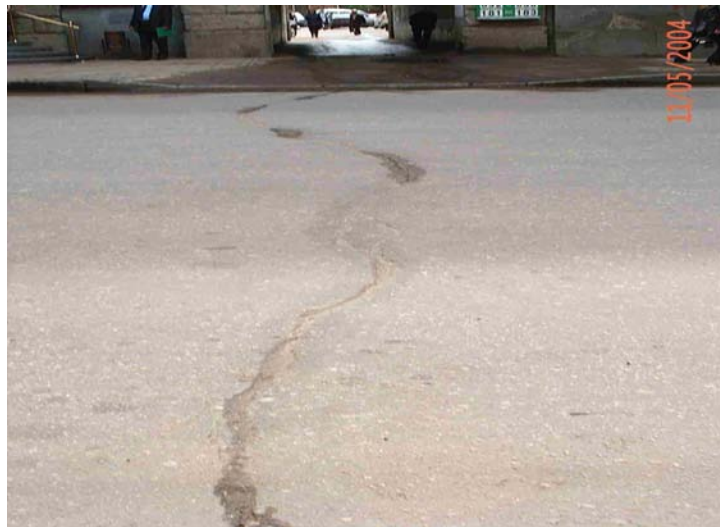
Results of visual inspection for determination of prevailing defects and failures of asphalt wearing course 1 km long in Sumskaia str. has shown dominant presence of transverse thermal cracks in the wearing course (Fig. 1). For the most part edges of transverse thermal cracks in asphalt surface course are deteriorated and opened to 2(3) – 15 cm. Sixty nine thermal cracks cross full width of the roadway. Thirty four cracks start at the curb and practically reach centerline of the street. Thirteen cracks cross the centerline but do not reach curb. Rehabilitation of asphalt wearing courses during service period was carried out by

Fig. 1 – General view of prevailing transverse thermal cracks with broken edges in asphalt wearing courses (Sumaskaia str., Kharkiv)

means of asphalt concrete layers buildup. Recently injecting repair technology of wide transverse thermal cracks with broken edges has been applied. It was implemented by means of special machine manufactured by “Savalko” using slurry seal mixture.

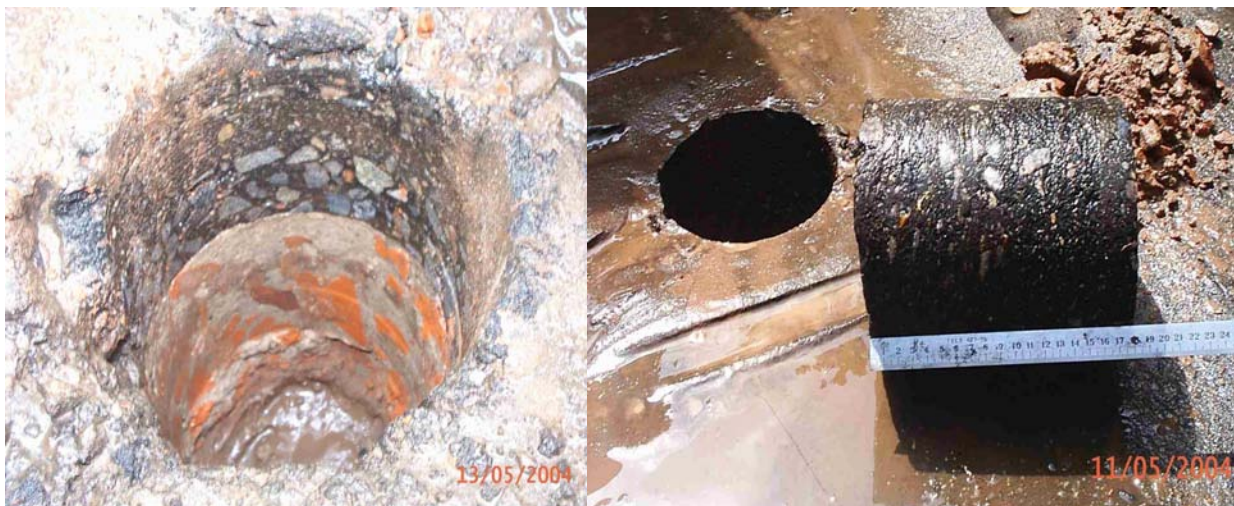
Coring of the pavement in areas without cracks in wearing course (Fig. 2) and with thermal cracks (Fig. 2) has shown that pavement consists of asphalt concrete layers 20 to 22 cm thick laid on the mineral material layer constituting mixture of broken bricks and ground concrete 25 to 40 cm thick. The material of base course was used during rebuilding period of roads and streets in Kharkiv after World War II.

Fig. 2 – General view of the core taken in the pavement area without cracks in wearing course

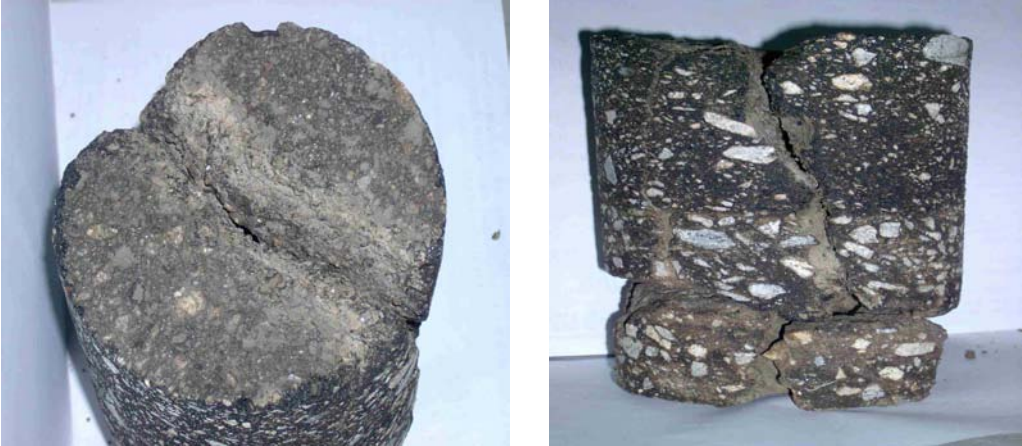
Survey results of cores taken from pavement has indicated that cracks with broken edges spread through total thickness of asphalt concrete layers, i. e. are through-the-thickness cracks (Fig. 3).

Fig. 3 – General view of the core taken from pavement with crack

It is apparent that traditional technique of asphalt wearing course rebuilding, which was applied earlier on the site, and included elimination of pits, subsequent application of

bitumen tack coating on old asphalt wearing course surface and laying of new asphalt concrete layer on it, cannot be effective. Experience of highways service shows that usage of such repair technology of road wearing courses with through-the-thickness cracks results in development of reflected cracks in new monolithic asphalt layer already in one or two years. After three years of service reflected cracks open and can be visually observed. Formation of reflected cracks leads to water saturation of base courses and subsequent decrease of bearing capacity of the whole pavement construction.

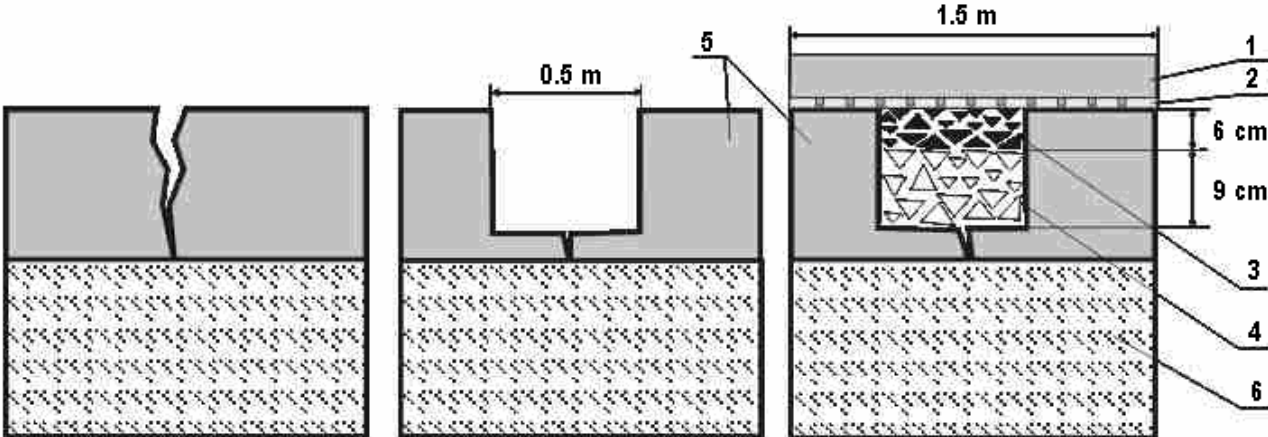
Fig. 4 – Schematic of through-the-thickness thermal crack cutting: 1 – new asphalt wearing course; 2 – geosynthetic reinforcing grid; 3 – coarse asphalt concrete; 4 – granite crushed stone; 5 – old asphalt concrete layers; 6 – base course

Suggested and accepted construction and technical decision lied in cutting of through-the-thickness cracks by means of disc cutter to the width of 50 to 60 cm and 15 to 16 cm deep. Crack cutting width depends on dimensions of manual reversing vibroplatform used for compaction. Scheme of transverse through-the-thickness cracks cutting is given in Fig. 4.

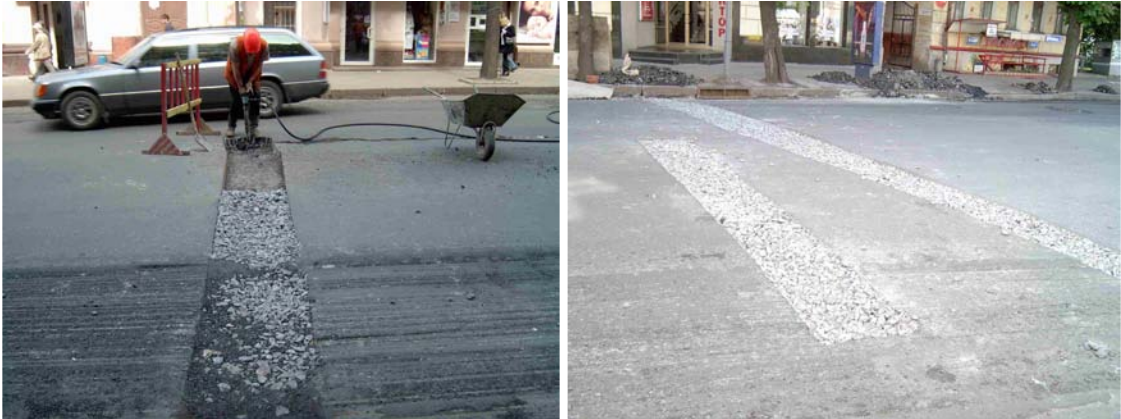
Fig. 5 – Cutting of through-the-thickness thermal cracks and crushed stone layer application

Proposed technology and scheme of through-the-thickness crack cutting allowed laying of crack stopping layer of crushed stone ranging from 5 to 20 mm 8-9 cm thick (Fig. 5) and a layer of coarse-aggregate porous asphalt concrete 6-8 cm thick (Fig. 6) instead of removed old asphalt concrete layers. Prior to laying of surface layer from fine-aggregate asphalt concrete mix (type “B” based on bitumen modified with 3 % of SBS polymer) on total width of the street runway, reinforcement of repaired areas over cracks with geosynthetic grid “Armatex RS 50/50” 1.5 m wide was performed (Fig. 7).

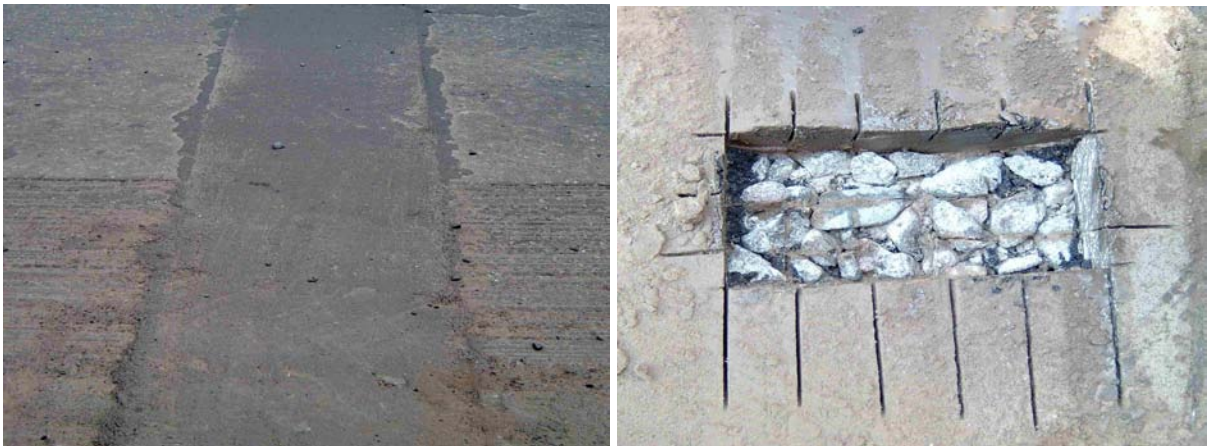
Fig. 6 – General view of site with coarse-aggregate asphalt concrete mix applied on crushed stone layer over the crack

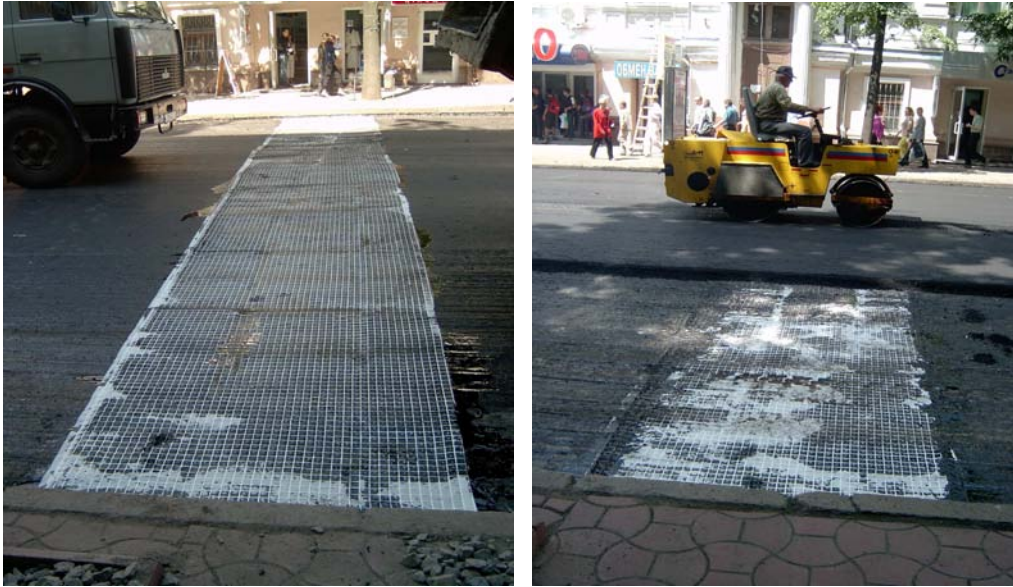
Fig. 7 – Reinforcement of wearing course over the crack repaired with geosynthetic grid “Armatex RS 50/50”

Two year monitoring of wearing course repaired by means of suggested technology has shown that reflected transverse cracks on it in areas of repaired through-the-thickness cracks did not appear as opposed to the site where traditional technology of asphalt wearing course repair by layers buildup was implemented.
